Bagnall Conservation Area Appraisal

The Bagnall Conservation Area Appraisal was adopted by Staffordshire Moorlands District Council on 11th September 2007, following public consultation.

Bagnall Conservation Area was established in 1972, and its boundary was amended in 1993.

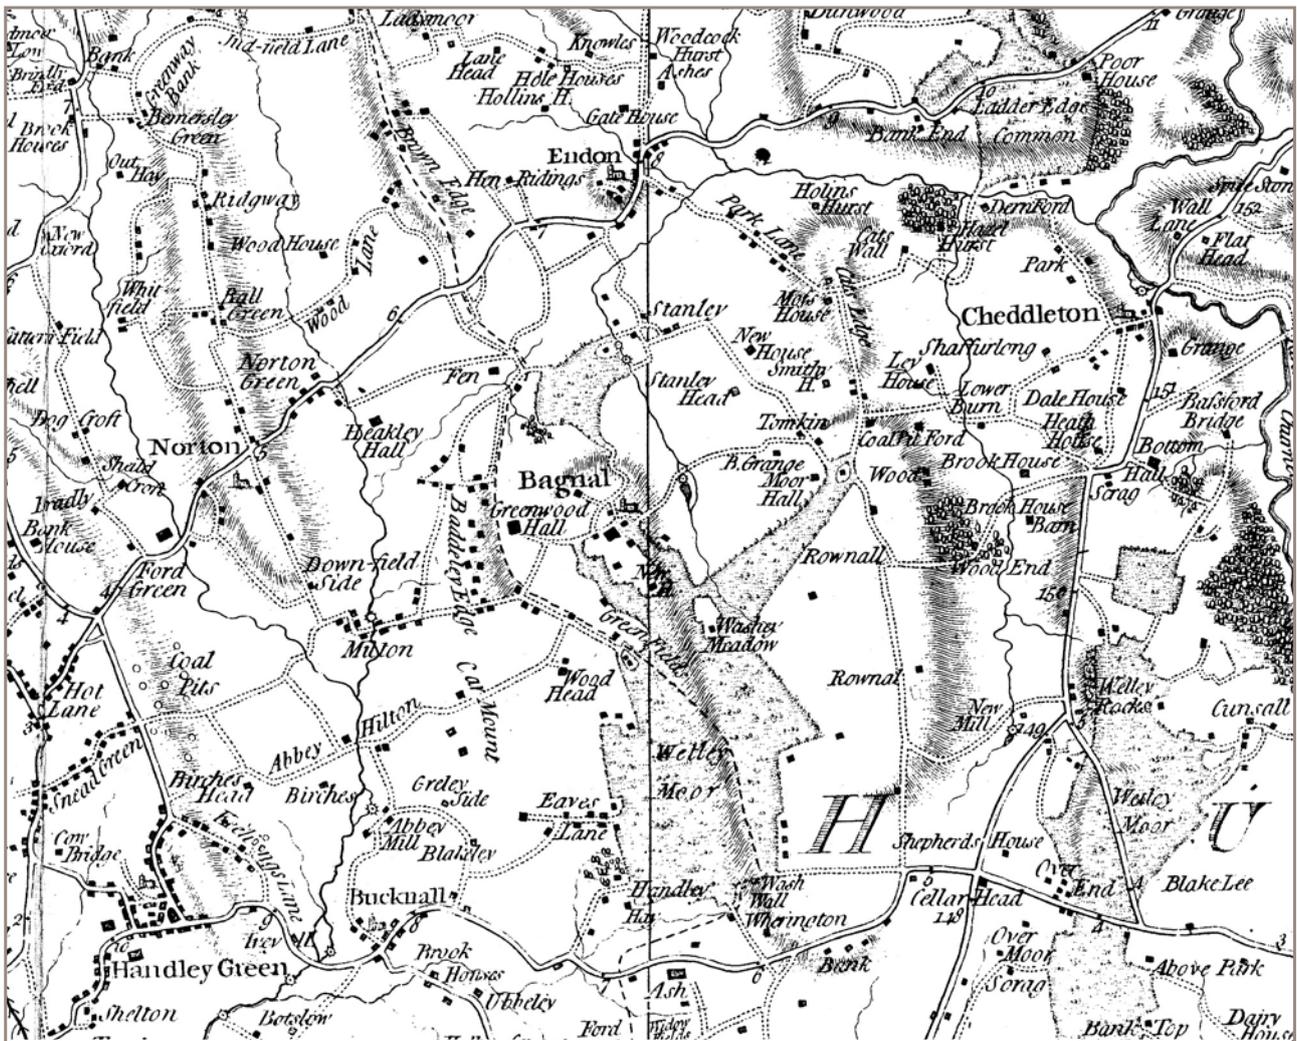
1.1 Bagnall as mapped by Yates in 1775. Moorland is shown stippled

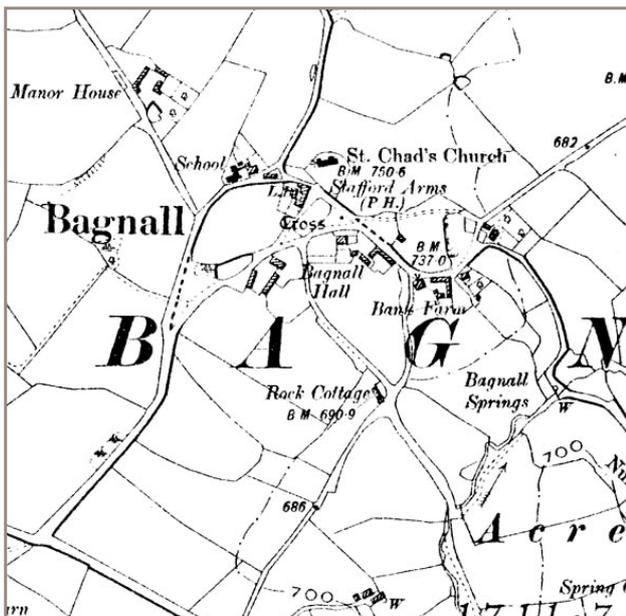
2.1 Bagnall in 1900

Either Bagnall Hall or Old Hall Farm was probably the site of a medieval manor house. The name Manor House for an outlying farm (2.1) is misleading as it belongs to a relatively late farmstead renamed in the mid-late 19th century.

- 2.5 A manor record of 1607 lists nine tenants,¹ eight were freeholders. Most lived in the central hamlet, where five large closes each had its own farmhouse;² the remainder occupied outlying farms at Bagnall Grange, Greenway Hall and Moor Hall.
- 2.6 By 1666 the township had nineteen households, a population of 85-100, reflecting rapid population growth and the establishment of new farms such as Greenway and Jackhayes. In 1851 the population was 219, reaching 288 by 1871, but the central hamlet saw little change before 1900. 'The Cottages' had been built, but additional households were mainly scattered in small-holdings on Stanley Moor (2.1).

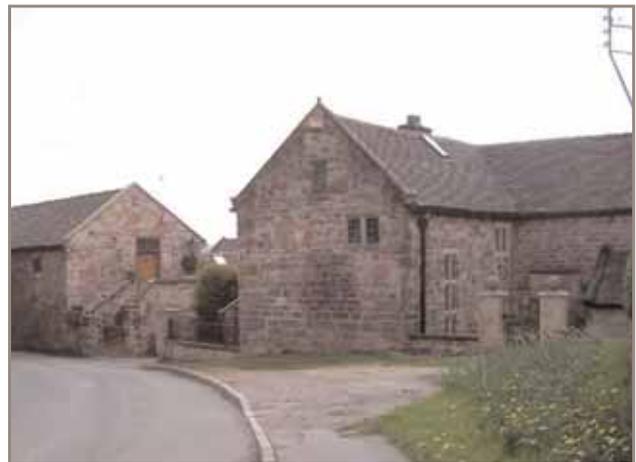
5.3 Bank Farm and its barn

- 5.3 The oldest building is Bank Farm, where 16th century timber framing is concealed behind 17th century stonework and an 18th century façade **(5.3 and Appendix 1)**.

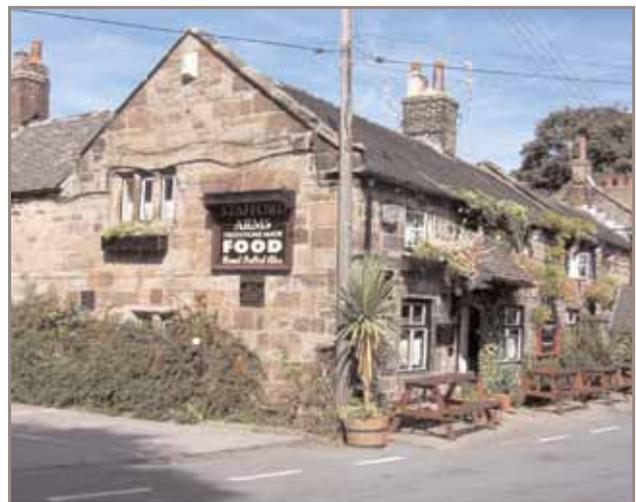
5.4 The Stafford Arms

- 5.4 The southern part of the Stafford Arms **(5.4)** was a 3-bay single pile farmhouse. Its rounded mullions suggest a date of around 1600. Forming part of the same range, St. Chad's House **(5.5)** also has traces of 17th century work but was substantially remodeled in the 19th century when its roof was raised, its upper windows repositioned, and the porch and unusual stone-roofed bay added.

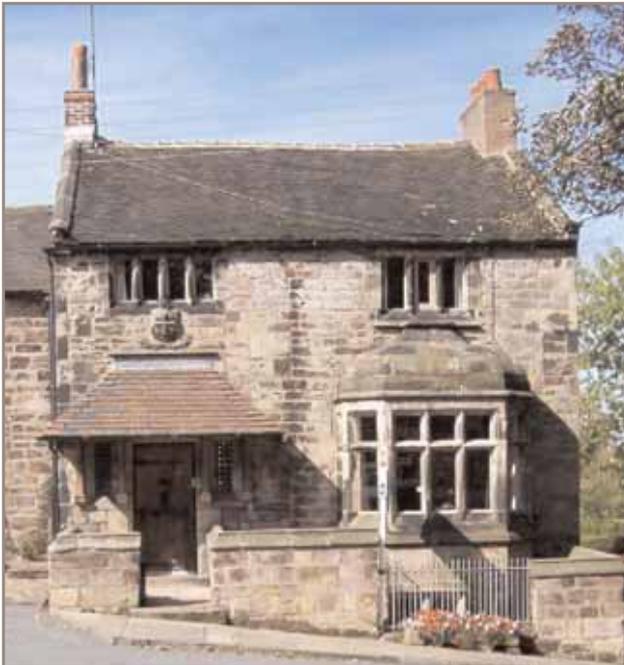
5.5 St. Chad's House

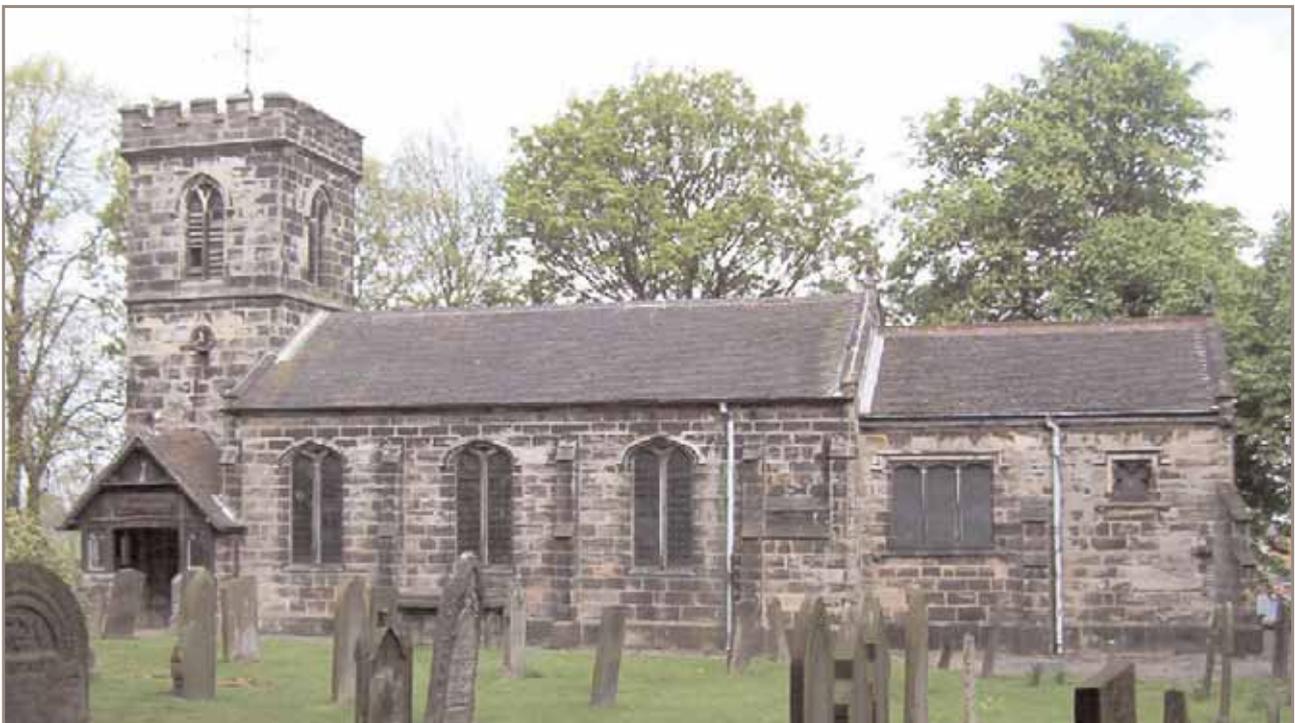
5.6 Bagnall Church

- 5.5 To the north of the conservation area is the church of St. Chad **(5.6)**. In the middle ages the township formed part of the parish of Stoke-on-Trent. By the 16th century Bagnall was a chapelry, one of several carved out of the main parish and given a small building to serve local needs. Some time after 1807 the chapelries of Bucknall and Bagnall (with Bucknall Eaves) became a separate parish. In 1834 the church of St Chad replaced the old timber-framed chapel, already ruinous by 1817. Built as a simple rectangular, the tower and chancel were added in 1878.

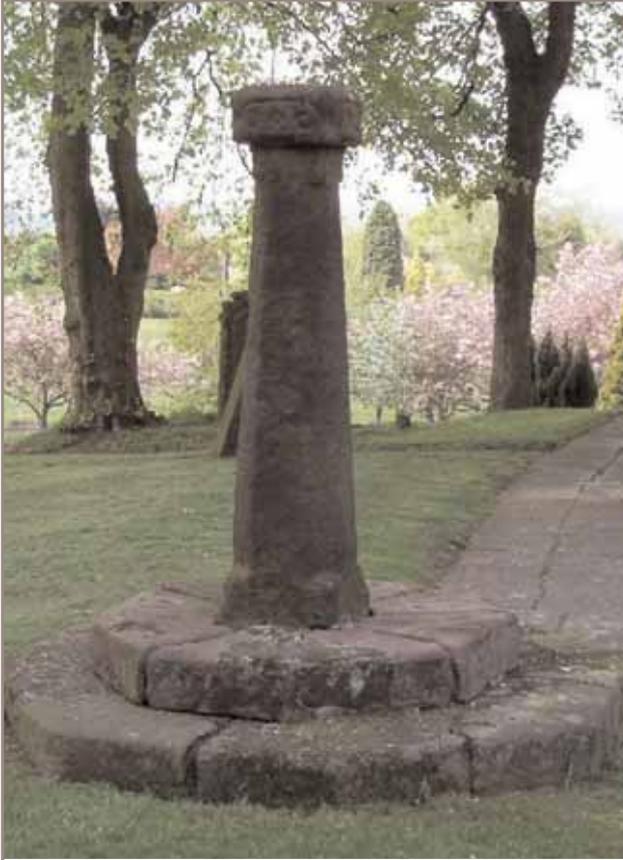
5.7 *The churchyard cross*

5.6 In the church grounds is a 17th century churchyard cross (5.7), a 19th century chest tomb (5.9), the lych gate (5.10) and on the green to the north of the Hall is a 16th century parish cross with a Celtic style crosshead (5.8).

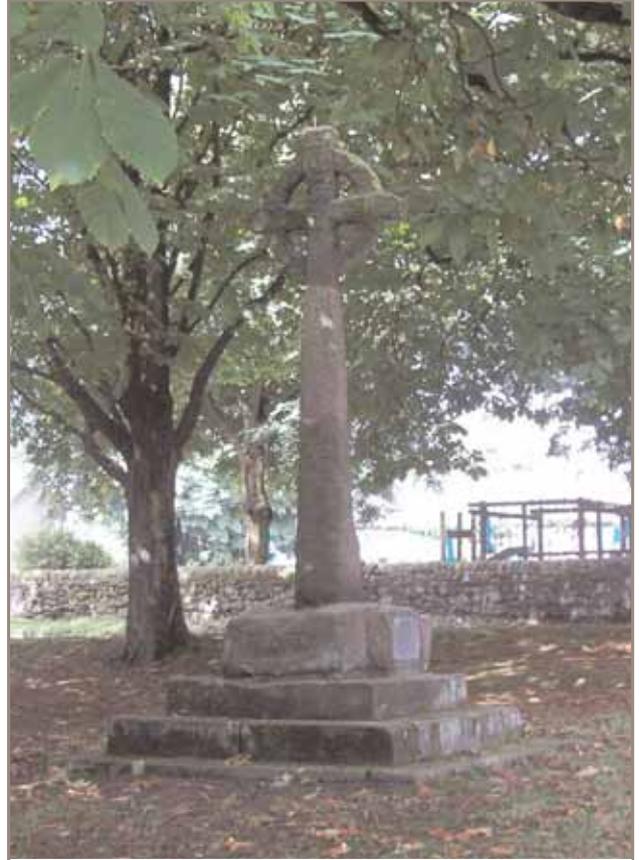
5.8 *The village cross*

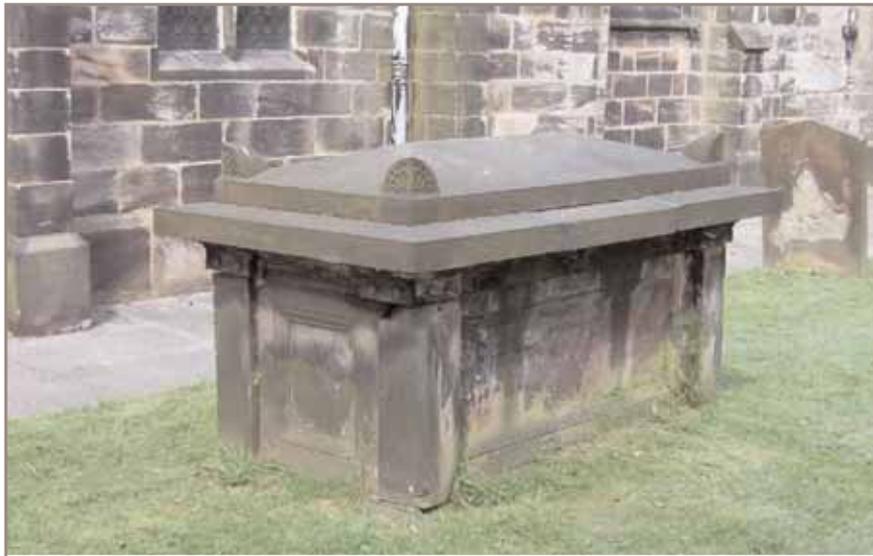
5.9 *The chest tomb*

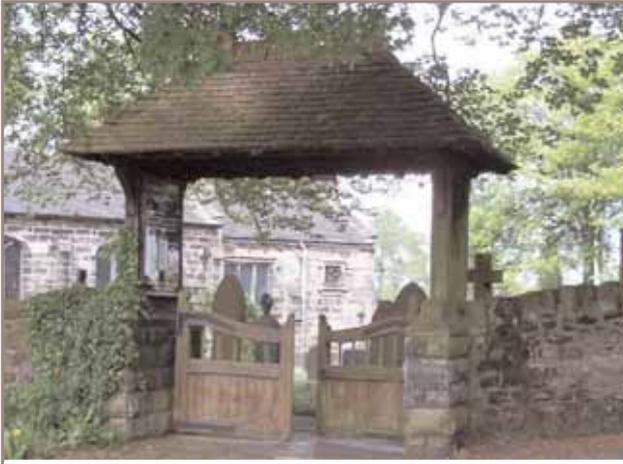
5.10 The Lych Gate

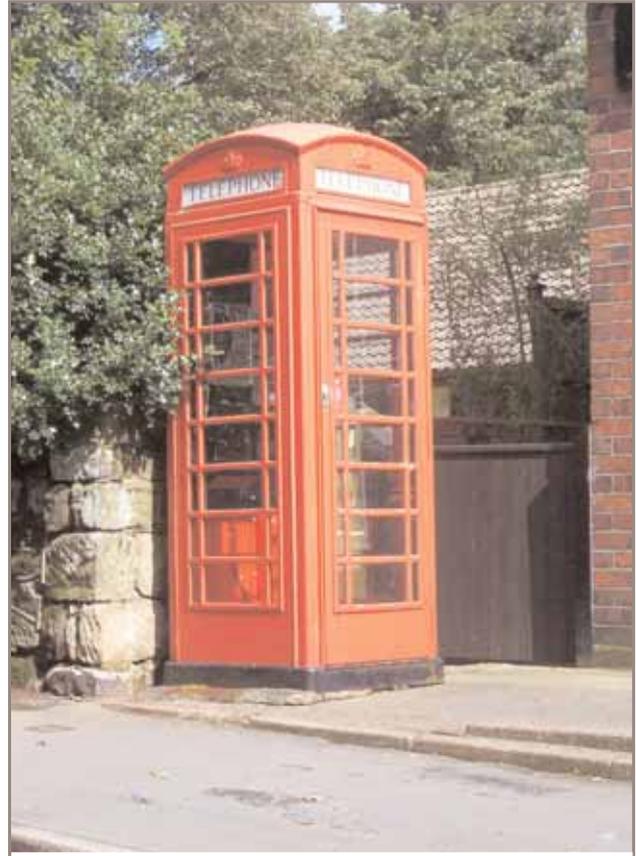
5.11 The telephone kiosk

5.7 The telephone kiosk is of a type designed by Sir Giles Gilbert Scott in 1935 (5.11).

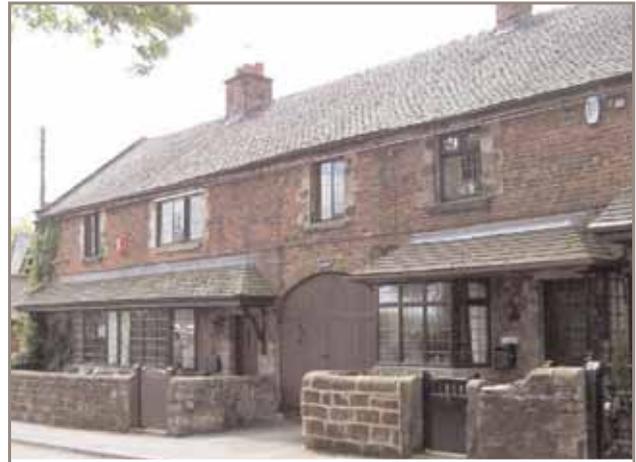
6.2 *The Cottages*

- 6.2 Of greater importance are 'The Cottages' (6.2), a row of brick houses occupying much of the road frontage south-east of Bagnall Hall next to St. Chad's Church Hall, an unpretentious brick building with a gothic touch (6.3). A small triangle to the north-west of St. Chad's House contains stone cottages (6.4). Beyond, lies the stone Old School House, extended to form the modern village hall (6.5).

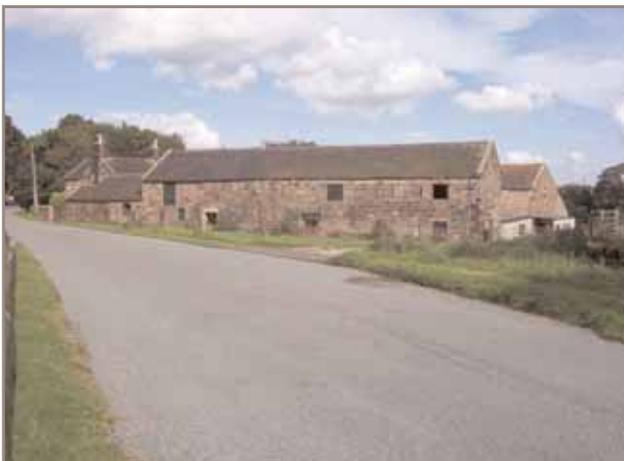
6.1 *Old Hall Farm*

- 6.1 Of the unlisted buildings the most significant belong to Old Hall Farm, rebuilt around 1800 (6.1) where the farmhouse and farm buildings are a strong reminder of the village's past. Of the early farmhouses only Bank House is unlisted. Shrouded in render it currently makes little contribution to the general scene.

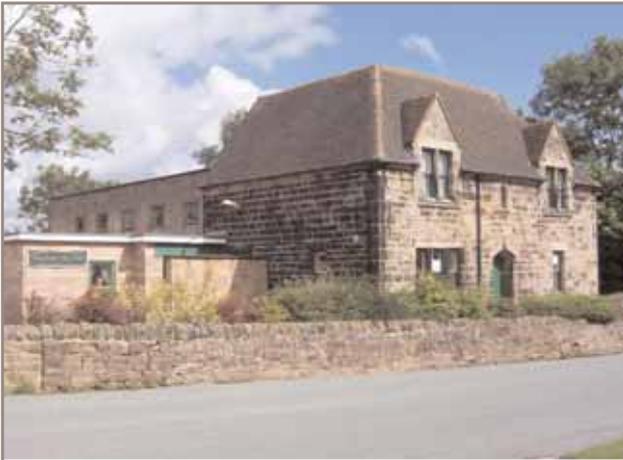
6.5 The village hall

8.21 Dormers rarely feature on vernacular buildings in North Staffordshire. By 1700 they are present on a small number of high status houses, set on the wall line and continuing the stone upwards to a small stone gable, or well inside the wall line to give lighting to a central attic space. Later, architect designed buildings like estate cottages may include dormers, but they are rarely found on traditional farm-houses and are not characteristic of early housing in Bagnall, where plain single pile roofs are standard, making Old School House (the village hall), a late architect designed exception (6.5).

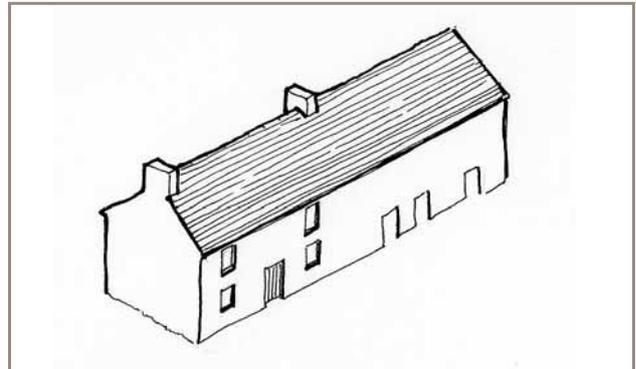
8.2 Farmhouse and farm buildings under one ridge line

8.2 Farmsteads with farmhouse and barn under one roof were cheaper to construct, and are found mainly in areas of late enclosure where smallholders were struggling to make ends meet (8.2). They are rare in village centres or on the older farmsteads.

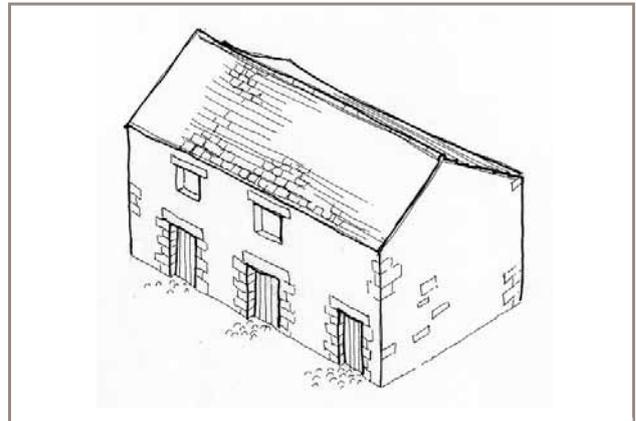
8.3 A three-door cattle shed with hayloft over

8.3 Large outbuildings may be called barns, irrespective of function. They may be cattle sheds with three or five smaller entrances and have haylofts with pitching holes (8.3), or threshing barns with a cart arch and threshing floor flanked by full-height storage space for grain crops and have narrow ventilation slits, or a combination of the two (8.4). Some have a granary on an upper floor accessed by an external staircase, as at Bank Farm.

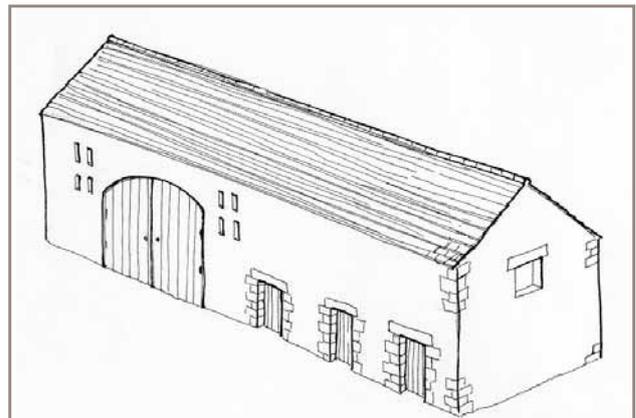
8.4 A threshing barn and cowhouse combined

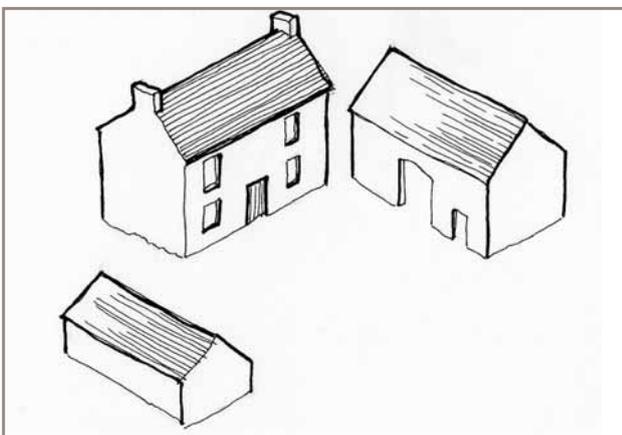
8.1 Farmhouse with detached farm buildings

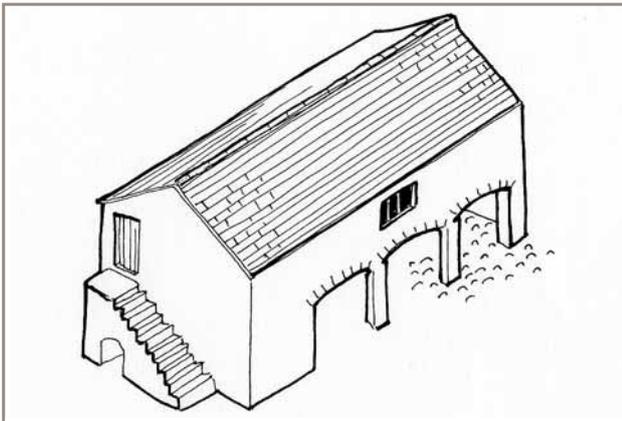
8.5 A shelter shed with granary over

8.4 Smaller outbuildings may include a granary over a cart shed (8.5), a stable, a shelter shed, or a pig-sty with a hen house above (8.6). The stable will generally be near the house, have a larger door than the cowhouse, and have a window adjacent to the door (8.7). A wide range of unaltered buildings survive at Old Hall Farm.

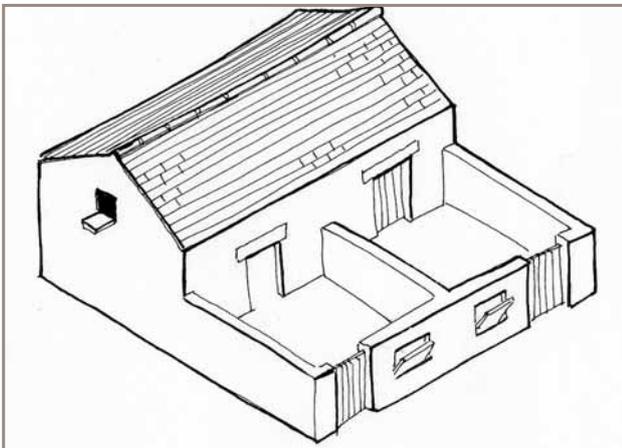
8.6 Pigsties with hen house over

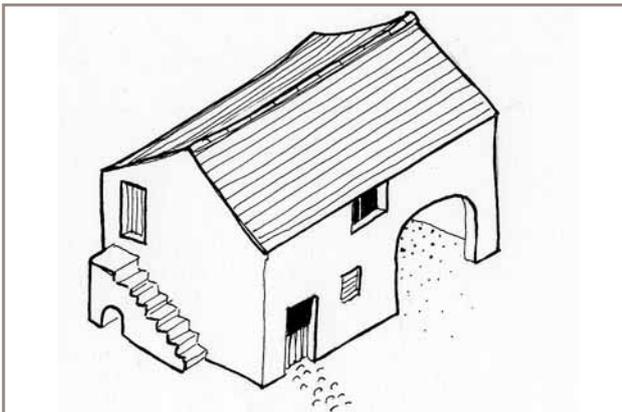
8.7 Hackney stable with granary over

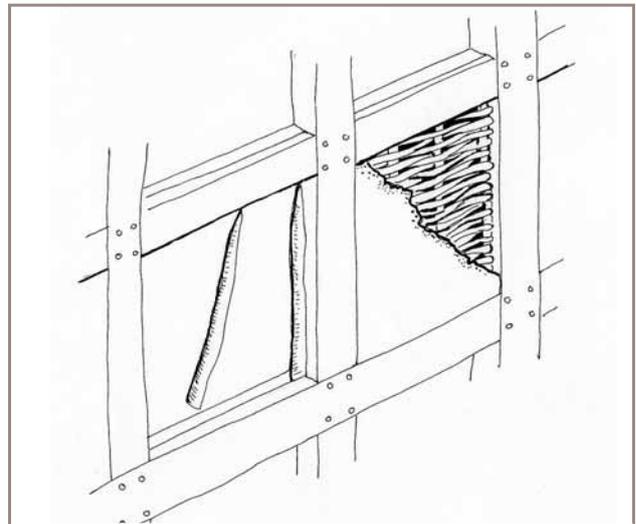
8.8 Square framing with wattle and daub

- 8.5 Oak was the main building material in the Middle Ages, except for high status buildings like churches where stone was more common. Bagnall had a timber chapel until its replacement in the mid 19th century. Where good building stone was absent, timber houses continued to be built well into the 17th century. None survives externally in Bagnall, but Bank Farm retains a 16th century closed-truss as the central division in the oldest part of the house (Appendix 1).
- 8.6 Walling consisted of either square framing with wattle and daub, or close-studding with split laths and plaster. Interior walls in stone buildings continued to be built in this way until the 18th century. (8.8)

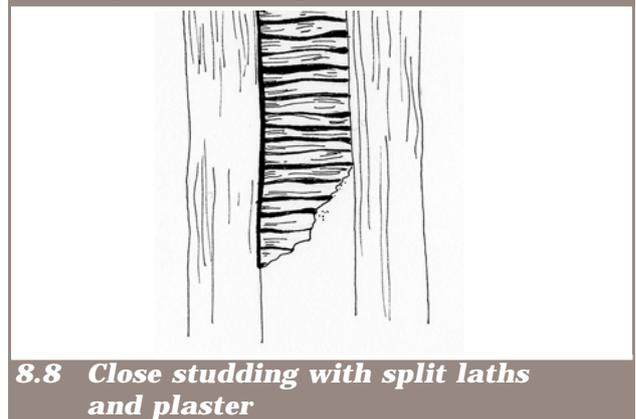
8.8 Close studding with split laths and plaster

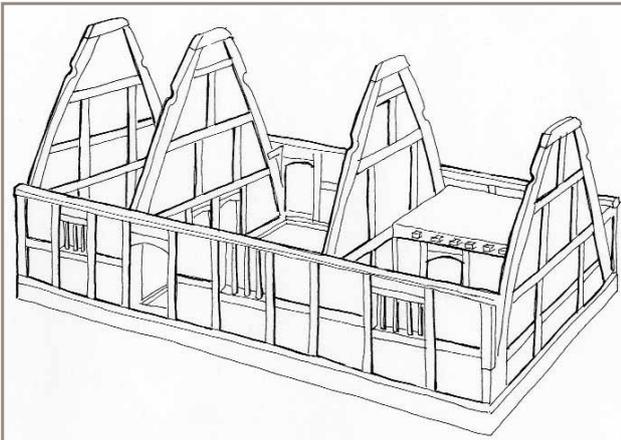
8.9 Cruck construction

- 8.7 Small buildings were often cruck framed with little or no headroom in the upper storey (8.9). A cruck survived at Bagnall Grange until the 1980s.
- 8.8 Larger houses were box-framed and had greater headroom (8.10), allowing full use of an upper floor, as at Bank Farm.

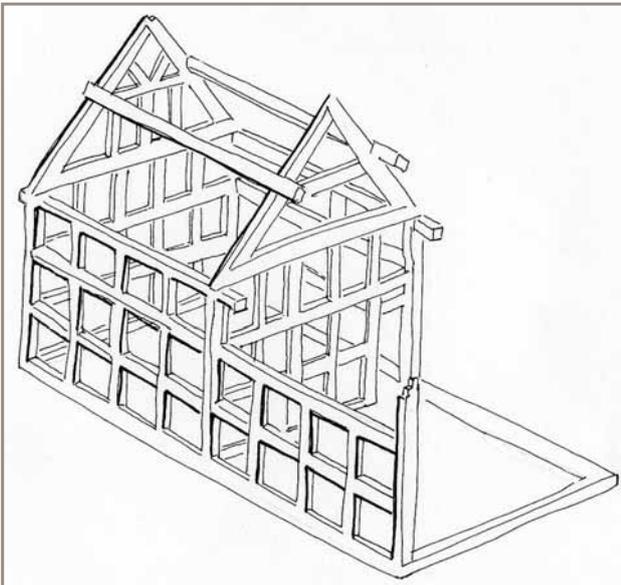
8.10 Box-framing

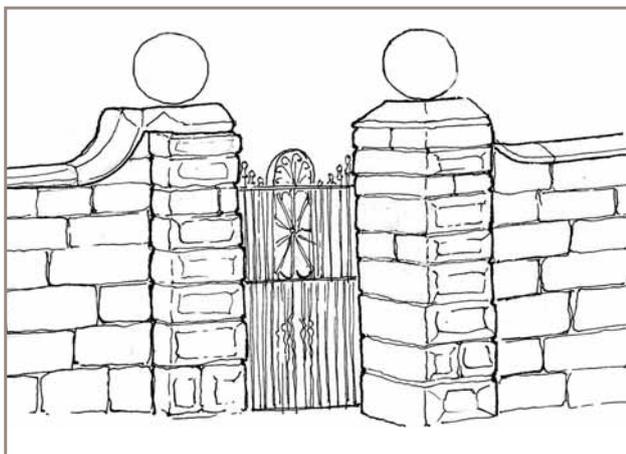
8.11 High status walling and gateposts

8.12 The status of a house and its owner were mirrored in the garden walls. Coursed walling with well-tooled capping stones and decorative gateposts were provided for gentry houses like Bagnall Hall (8.11), and drystone walls with simple capping stones form the boundary walls for farmhouses and cottages. (8.12). The latter are of particular importance to small rural communities like Bagnall where modernisation and gentrification are tending to erode the true character of the area.

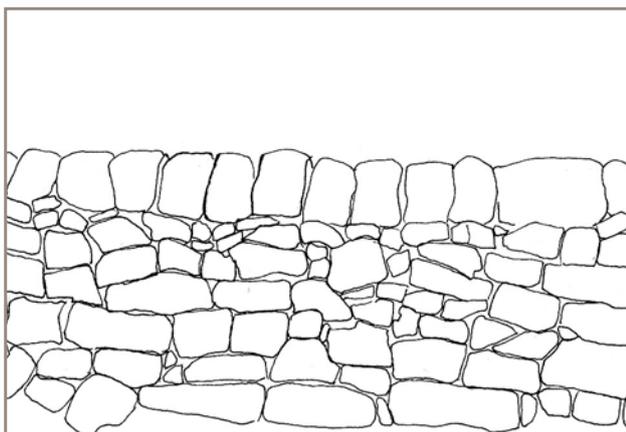
8.12 Drystone walling with the traditional half-round of coping stones

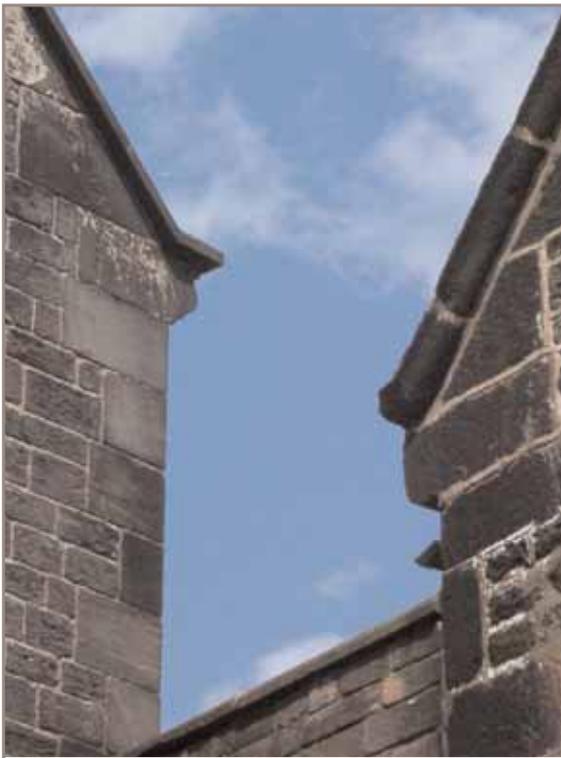
8.13 *Coping stones and kneelers*

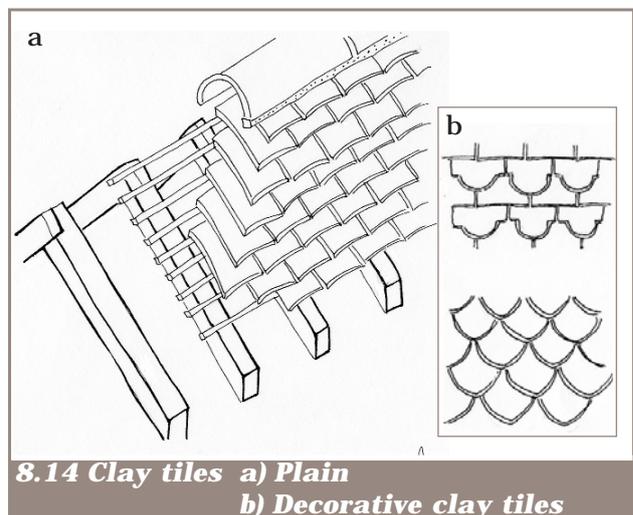
8.14 *Clay tiles a) Plain
b) Decorative clay tiles*

- 8.18 Stone slates were used on the better quality housing. These are now relatively rare, but may survive as a few courses at eaves level with tiles or welsh slate above. Where there is no sign of the long walls having been raised, and no great depth below the coping stone, slates are likely to have been the original roofing material.
- 8.19 The 19th century saw the expansion of the Potteries coupled with new and better forms of transport. With these came the mass production and distribution of the clay roofing tiles, now regarded as the typical local roofing material. The majority are plain rectangular tiles, but 19th century roofs may have alternate bands of plain and fish-scale or acorn tiles. All were handmade and have an irregularity that cannot be simulated by modern machine made tiles. In Bagnall only plain tiles are in evidence.

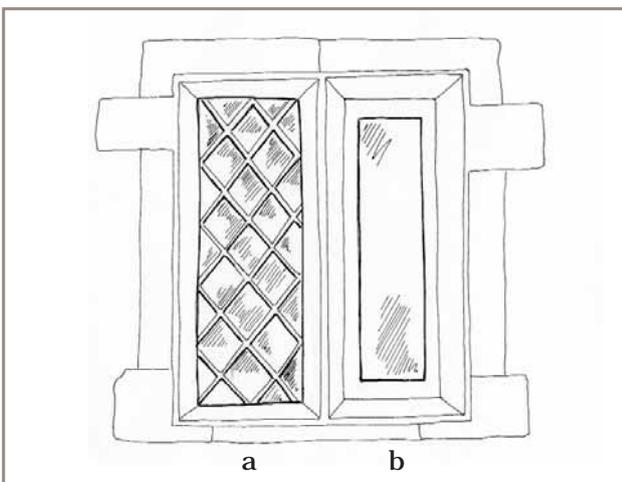
8.15 Mullioned windows: traditional and non-traditional methods of glazing
 a) leading with diamond panes
 b) wooden frame with single pane

8.24 In the earliest houses glazing was applied straight into the structural surround, without recourse to a wooden window frame. As a result, modern window-frames sit uneasily in 17th or early 18th century window openings, blocking the light and appearing clumsy, an effect compounded by the addition of double-glazing (8.15).

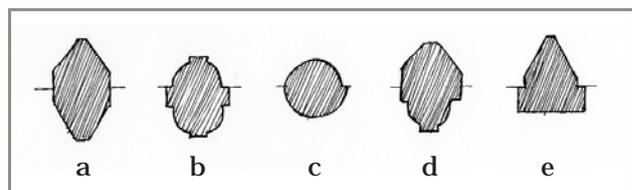
8.16 Mullions: changing styles

- a) chamfered
- b) ovolo
- c) rounded
- d) chamfered and ovolo
- e) block mullion

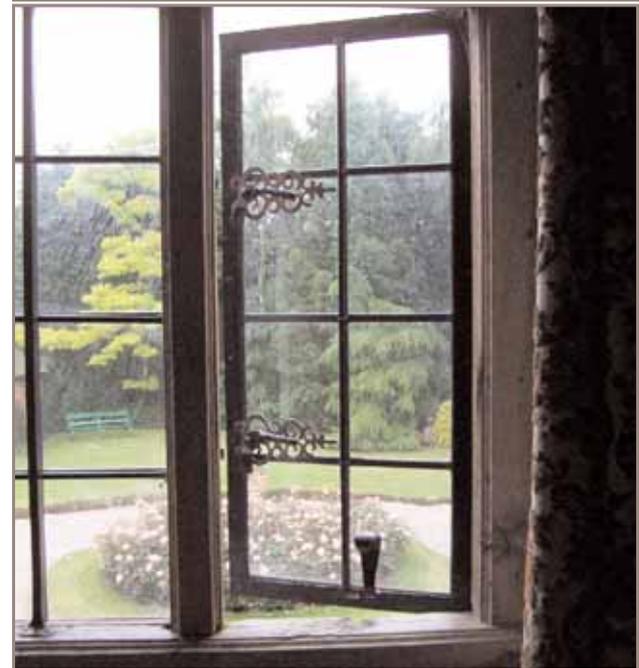
8.17 Casement windows

a) 18th century metal casement

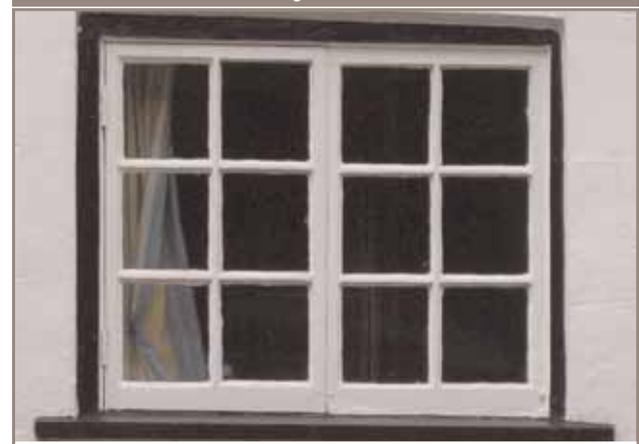
b) 19th century wooden casement

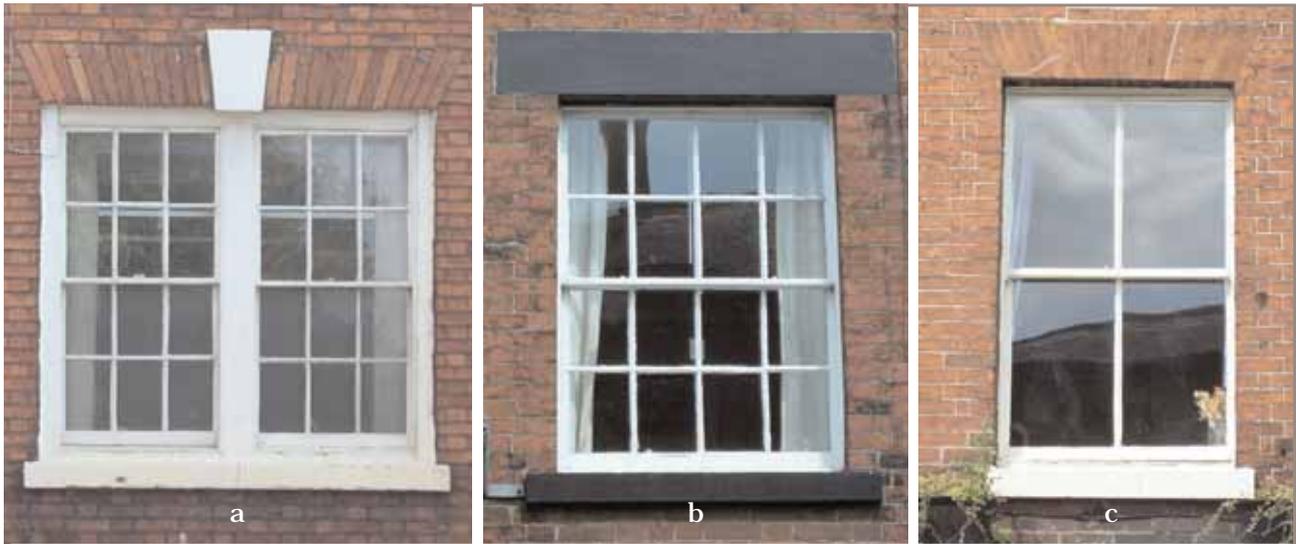
8.18 Vertical sliding sashes

a) 18th century, exposed sash boxes, 6 over 6 panes

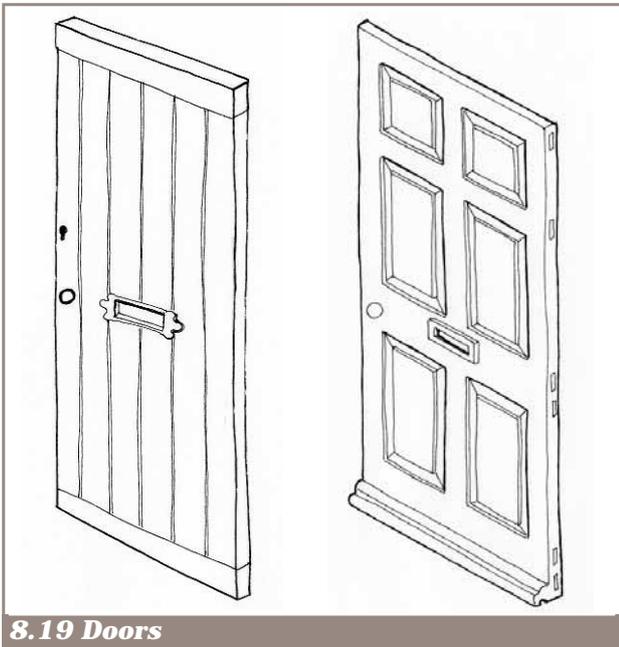
8.36 Door styles also vary. The simpler buildings in both town and country had vertically boarded doors, as did farm buildings, and most ecclesiastical buildings. Farm buildings might include stable doors with an upper section which could be fixed open while the lower section remained closed. Panelled doors are common both inside and outside in high status buildings, and were often used for the front door of a farmhouse in contrast to plank doors at the rear or in the interior (8.19).

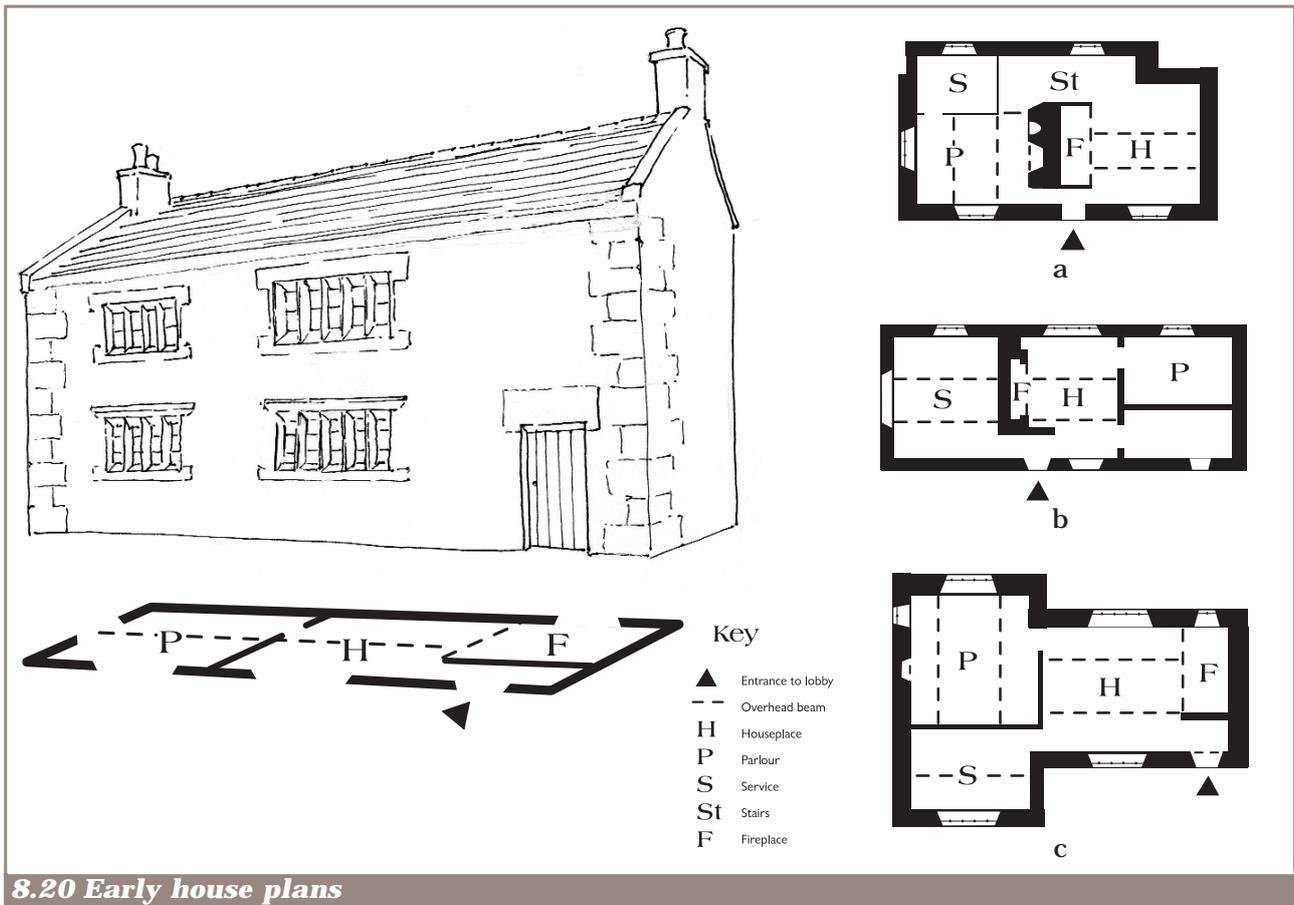
8.20 Early house plans

8.42 Each had a characteristic arrangement of rooms and windows. In the earlier houses you can read exactly how the house worked from the placing of the doors and windows. In later houses a polite façade tends to mask the internal working of the house. Each is characteristic of a period and part of the essential character of the house.

8.43 Medieval houses had a hall open to the roof entered from a cross-passage that served both front and back doors. By 1600 new plans were becoming fashionable which included a lobby entrance between the doorway and the fireplace. This was usually the only entrance, and acted as an internal porch to reduce draughts. On the opposite side of the building a small fire window was introduced to light what estate agents know as the 'ingle nook'. Other windows were kept to a minimum, one to a room, so that the internal arrangements are clear from the outside of the building as at Jack Hayes.

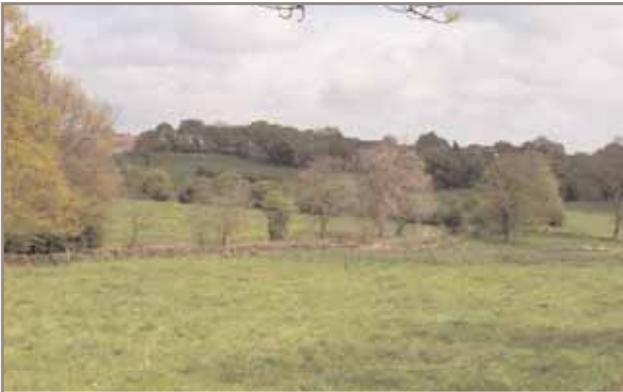
9.1 *View in from the south showing the siting of the hamlet*

9.1 Bagnall lies on high ground on the fringes of the Pennines. Away to the west lies Baddeley Edge where the land drops sharply past former squatter settlements to the low-lying area of the Potteries. South of the village, where Wetley Moor once stretched, long straight roads, the product of Parliamentary Enclosure, provide distant glimpses of the hilltop settlement (9.1).

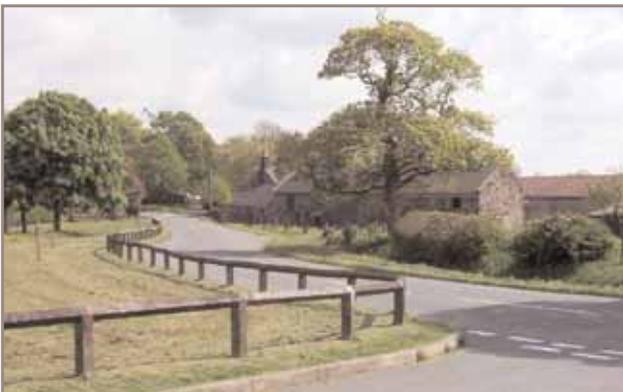
9.2 *View in from the south west to Old Hall Farm*

9.2 Entering the village from the south, the surviving portion of Close 1 creates an essential barrier between old buildings and new (9.2), and gives an unbroken view of Old Hall Farm.

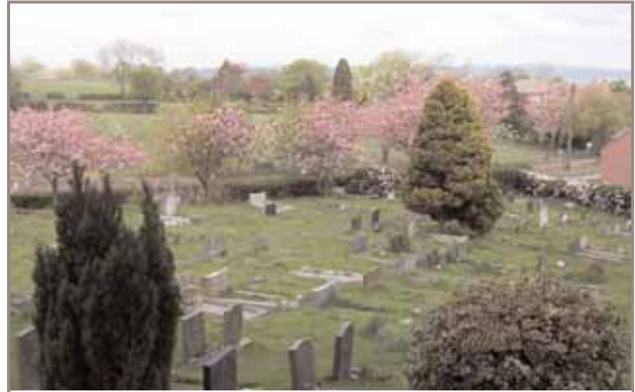
9.3 *View out from the churchyard to the north west*

9.3 To the northwest the land drops sharply to Stanley Moor, partly masking 20th century development. Outward views across field and playing field are still available from the churchyard (9.3).

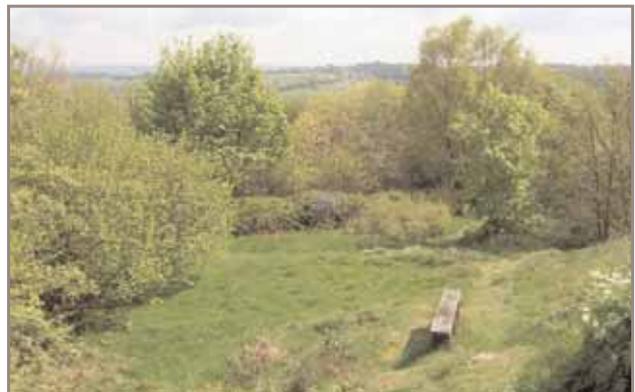
9.4 *View out to the north east over former quarry*

9.4 Where a footpath leaves across the green, scattered trees allow distant glimpses of wider views (9.4) including the high ground round the Roaches (9.5) while southwards, the back gardens allow glimpses of gently rolling countryside with small fields and plentiful tree cover.

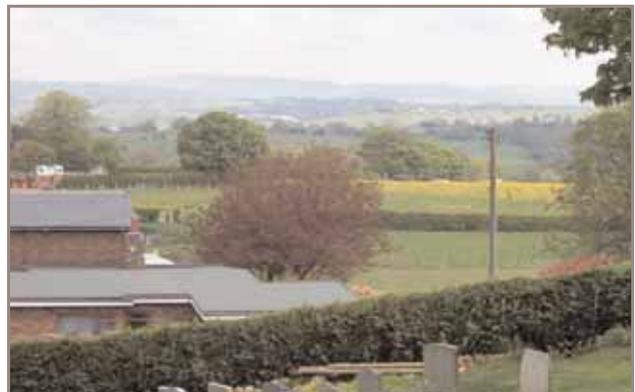
9.5 *View out to the north east towards the Roaches*
