Horton Conservation Area Appraisal

The Horton Conservation Area Appraisal was adopted by Staffordshire Moorlands District Council on 11th September 2007, following public consultation.

Horton Conservation Area was established in 1970

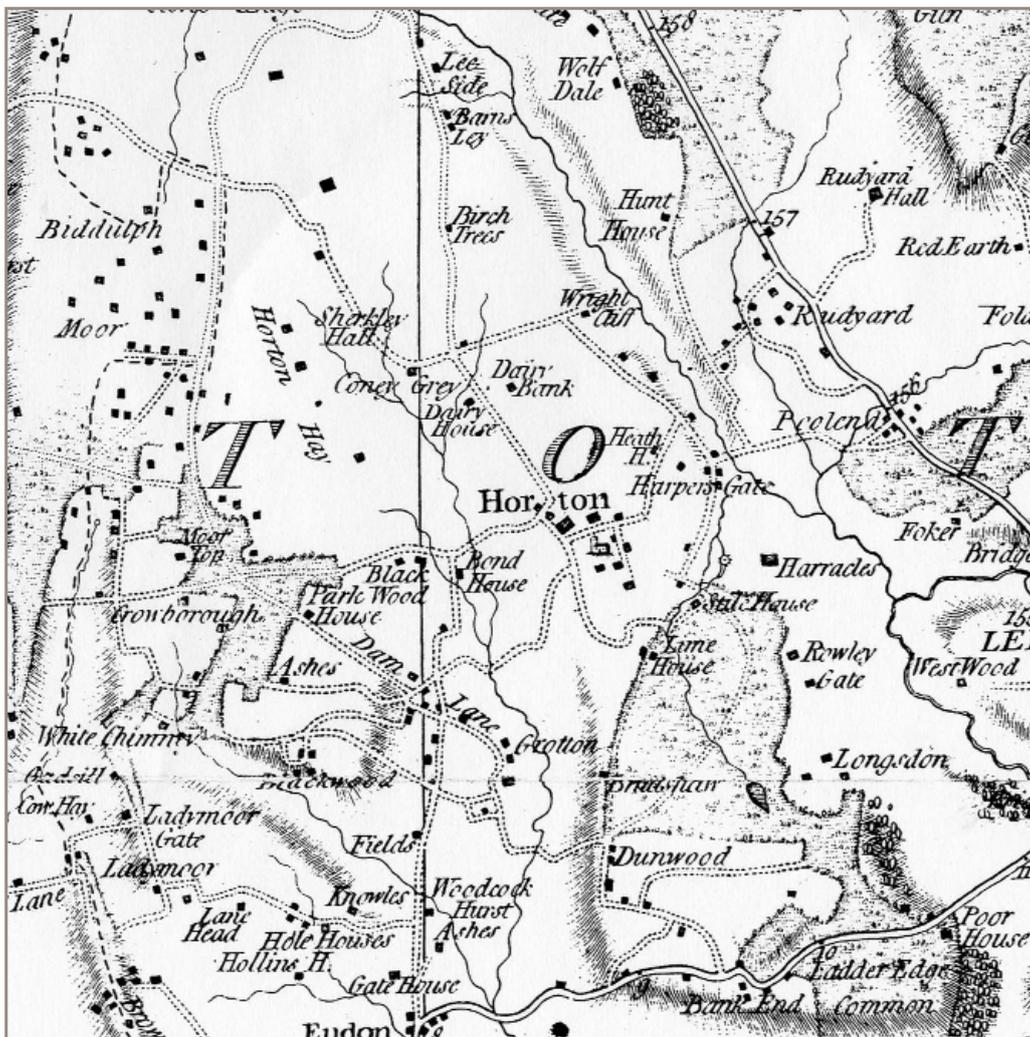
1.1 Horton as mapped by Yates in 1775. Moorland shown stippled.

2.2 Horton is a 'planned settlement', a miniature of those which developed in the more densely populated areas of England between 900 and 1200, and originated as a single row of houses fronted by a lane, beyond which lay the main arable fields. Parallel to the lane was the 'back lane', now part footpath, and part road and trackway. Yates' map of 1775 shows each of the historic farmhouses, and part of the back lane leading out to Horton Head (1.1).

2.4 Four of the historic farms flank the main street, while Horton Head is at the southern end of the 'back lane' as shown by Yates in 1775 and still shown on Ordnance Survey maps in 1900 (1.1 and 2.1). Between the road and the back lane, and forming the core of the settlement, is a cluster of buildings including the church, the vicarage, and the former Crown Inn. To the east the Conservation Area boundary has been drawn to include an extension to the graveyard.

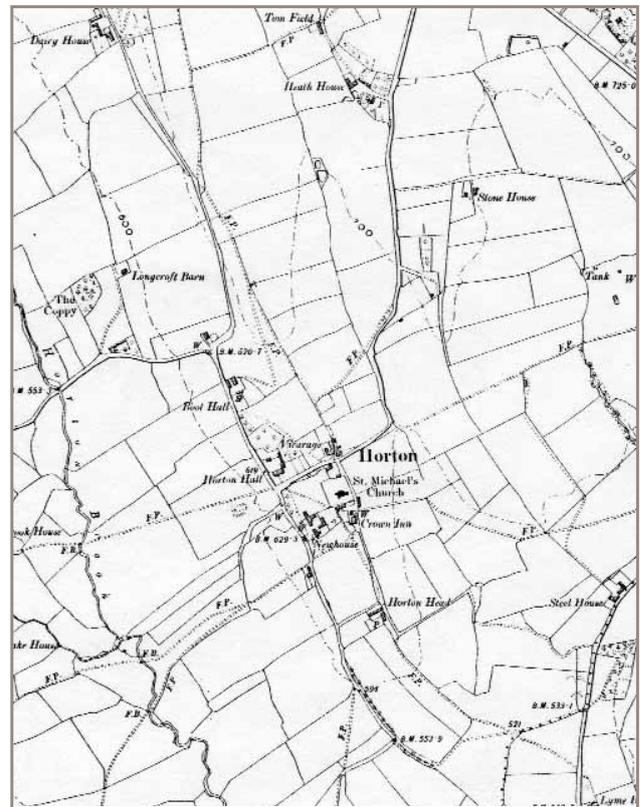
2.1 Horton in 1900 (from the 6" Ordnance Survey map). The back lane can be seen continuing to the north and south of the hamlet to the rear of Horton Head. To the south west, long narrow fields with curving field boundaries indicate the position of the former arable land.

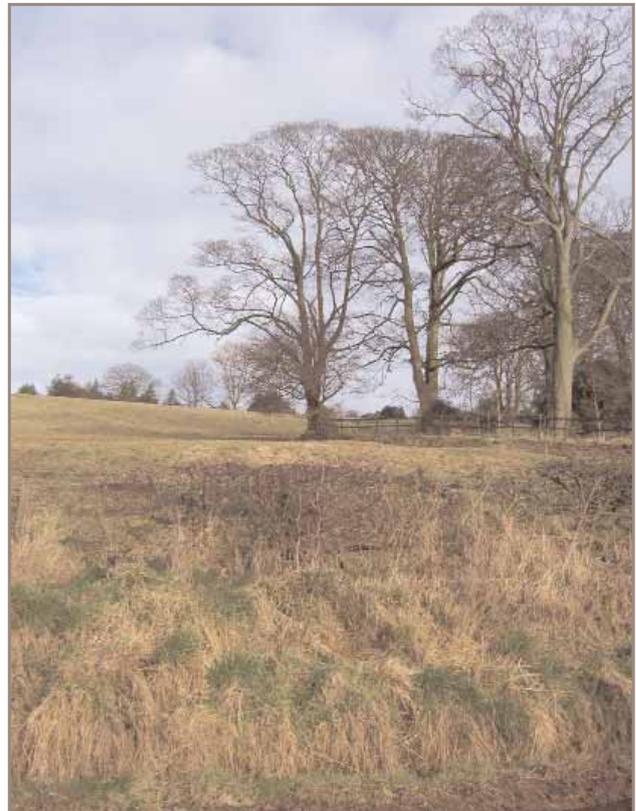
4.1 *House platform to the north-west of Horton Hall*

- 4.1 The village of Horton is a planned settlement of medieval origin. The spacing of the farms suggests it has shrunk, and that there may be potential for archaeological investigation of house platforms should development take place (4.1).
- 4.2 No Scheduled Ancient Monuments exist within the Conservation Area.
- 4.3 Unscheduled features lying outside the Conservation Area include:
- the boundary and earthworks of Horton Hay
 - a clapper bridge over Horton Brook (4.2) (Listed II; SJ938569)
 - a major dam at SJ935573.
 - bloomery sites at Cinderfield (SJ922582), Coneygreave (SJ932585), and Halfway House (SJ923596)
 - ridge and furrow in fields to the west of Horton Hall
 - the 'Hall' field names adjacent to the Dairyhouse which may imply the site of a manor house.

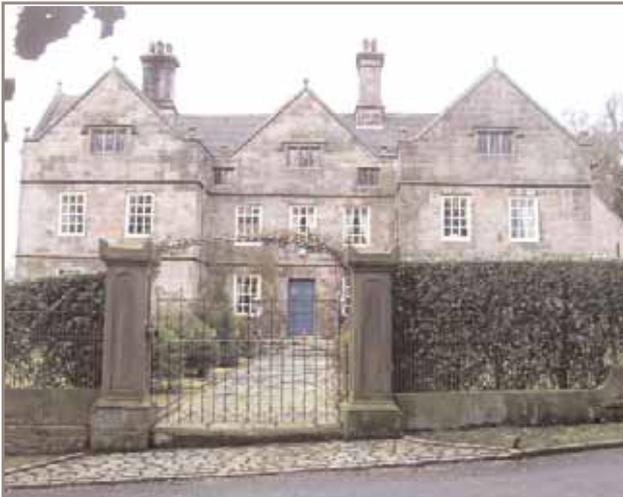
5.1 Horton Hall: the main façade

- 5.3 Horton Hall is among the most impressive of the yeoman farmhouses in North Staffordshire, and the most dominant building in the Conservation Area (5.1). Built for Timothy Edge or his father Richard, its south face gives the impression of belonging to a typical H-shaped 17th century house, with a central hall flanked by parlour and service wings, albeit on a larger than average scale. Looks are deceptive. Above average in both size and craftsmanship, the hall roof has a catslide covering a double pile, allowing the staircase and service rooms to fill the space between parlour and service wings.

- 6.4 The boundaries to the Hall are equally varied. To the south is a pillared entrance flanked by cast iron spearhead railings and neat hedging (5.1). The western wall nearest the house was built for Timothy Edge with a garden gateway marked TE 1668 (5.3), next comes neatly coursed 19th century walling between capped pillars, and finally dry stone walling as the property approaches open countryside (5.4).

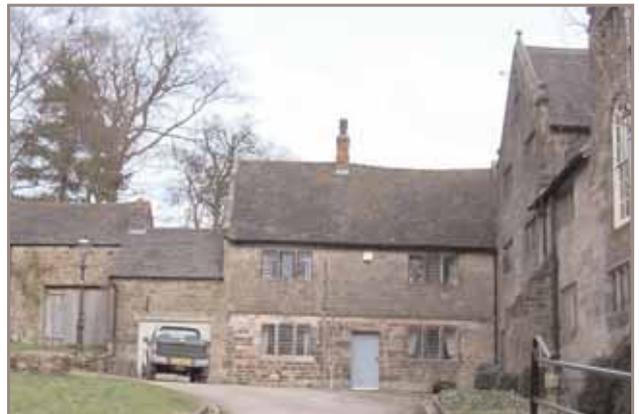
5.3 Horton Hall: the attached outbuildings

- 5.4 Attached outbuildings at right angles to the Hall (5.3) were added in the early 18th century as additional kitchen-quarters, and form one side of the rear courtyard. On its northern side the outbuilding (5.4), formerly a stable with hayloft above, is now holiday accommodation. The boundary walls, with a gateway inscribed TE 1666 (5.5), were built for Timothy Edge, whose inventory shows he was one of the wealthiest men in the Moorlands (Appendix 2).

- 7.33 It is rare for 17th century glass to survive, and rarer still for it to be in its original leadwork. Most mullioned windows contain replacements, either a single sheet of glass set straight into the stonework, set in a metal surround, or set in a wooden surround, with or without a casement. Diamond panes have been retained in the attic windows of the 17th century [Horton Hall \(5.1\)](#), and rectangular panes in the [attached outbuildings \(5.3\)](#) which are later.

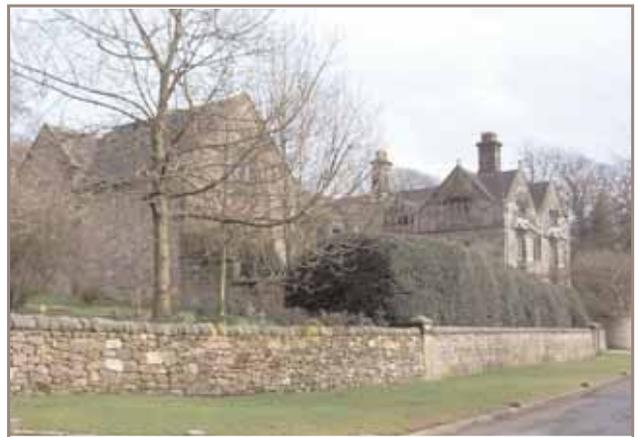
5.4 Horton Hall: with its stable block

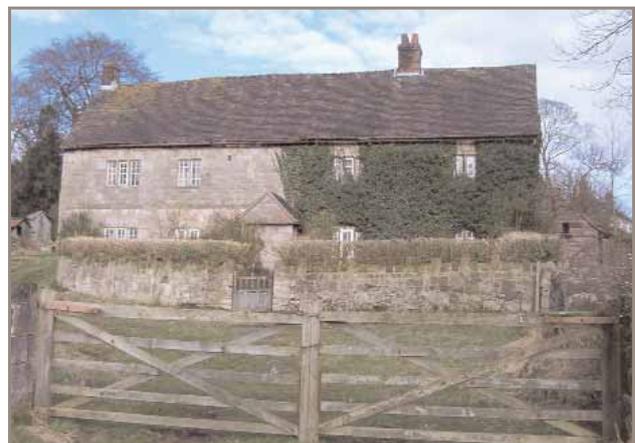
5.7 *Newhouse: the main façade*

5.6 Newhouse (5.7) was re-fronted in the first half of the 18th century. It is a single pile farmhouse,⁵ and there is a sharp contrast between the small, early windows at the rear, and the larger more regular windows of the front, although both have chamfered mullions. The farmhouse retains early leaded windows with metal casements, and has seen little if any alteration in the 20th century.

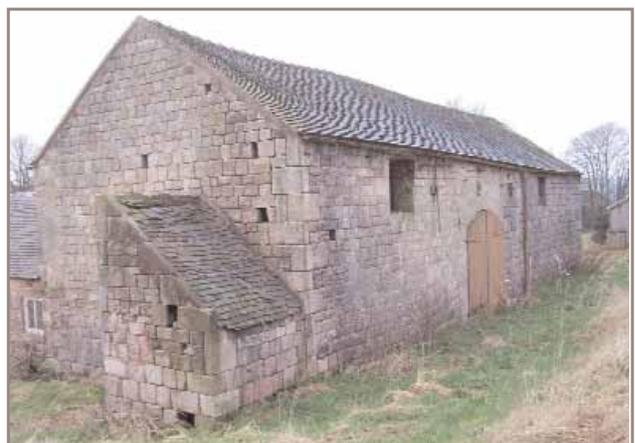
5.8 *Newhouse: barn*

5.7 Both Boot Hall and Newhouse have a series of curtilage buildings, some of which are listed in their own right. The best preserved of the Newhouse barns (5.8) is a combination barn with a cowhouse at one end and a threshing barn with full-height doors at the other. A series of original internal features includes cattle stalls. The main barn at Boot Hall (5.9) lies at the roadside adjacent to the house. It is principally a cowhouse with a hayloft over. Its roof pitch and coping suggest it too is of 17th century date.

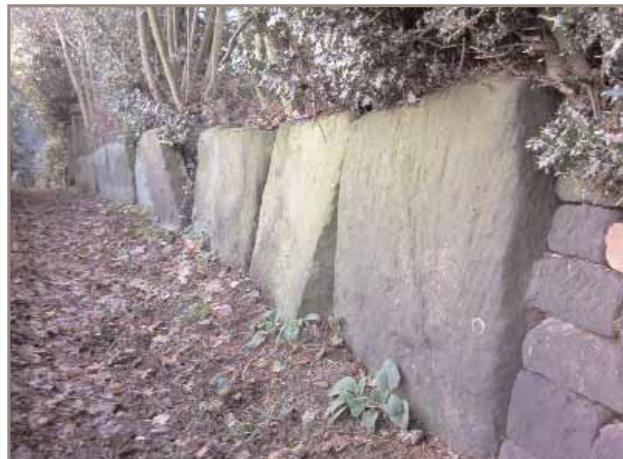
6.1 Massive vertical boundary stones

- 6.2 Stone walls predominate around the Hall and the Church. Simple dry stone walling revets the eastern boundary of the churchyard (5.16), while the southern boundary consists of vertical slabs (6.1).

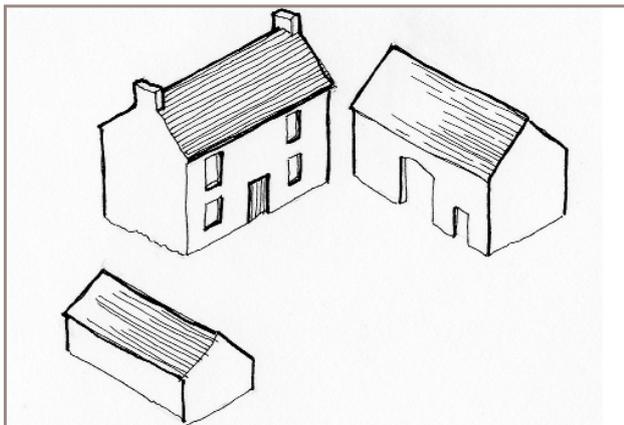
7.1 Farmhouse with detached farm buildings

- 7.1 Traditional farmsteads in North Staffordshire consist of a detached house, and one or more detached outbuildings serving a variety of functions (7.1). There is no set pattern to their arrangement, which is designed to fit the lie of the land. On steep slopes large buildings follow the contours, on gentler ground they may be arranged round a courtyard. The farms in Horton show a variety of arrangements, but in the majority of cases both the farm house and its main farm buildings are aligned south-east / north-west, reflecting the contours of the ridge behind them. The exception is Horton Hall, where the house is built across the contours to allow the parlour wing to be built with a substantial semi-basement containing service rooms.

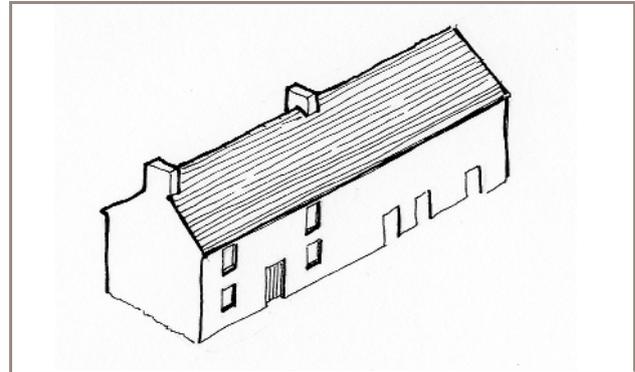
7.2 Farmhouse and farm buildings under one ridge line

- 7.2 Farmsteads with farmhouse and barn under one roof were cheaper to construct, and are found mainly in areas of late enclosure (7.2). They are rare in village centres or on the older farmsteads. There are none in this Conservation Area.

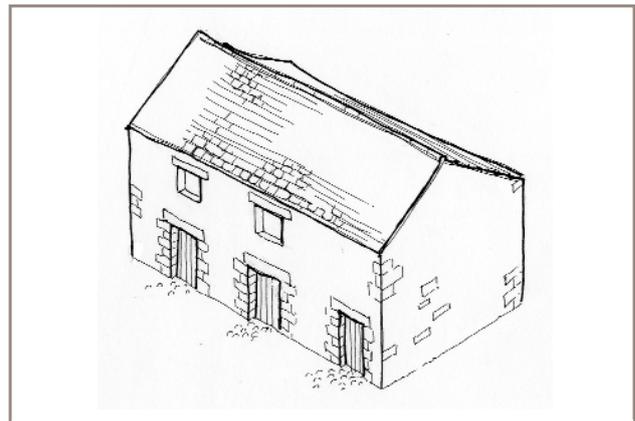
7.3 A three-door cattle shed with hayloft over

- 7.3 Large outbuildings may be called barns, irrespective of function. They may be cattle sheds with three or five smaller entrances and have haylofts with pitching holes (7.3), or threshing barns with a cart arch and threshing floor flanked by full-height storage space for grain crops and have narrow ventilation slits, or a combination of the two (7.4). Some have a granary on an upper floor accessed by an external staircase.

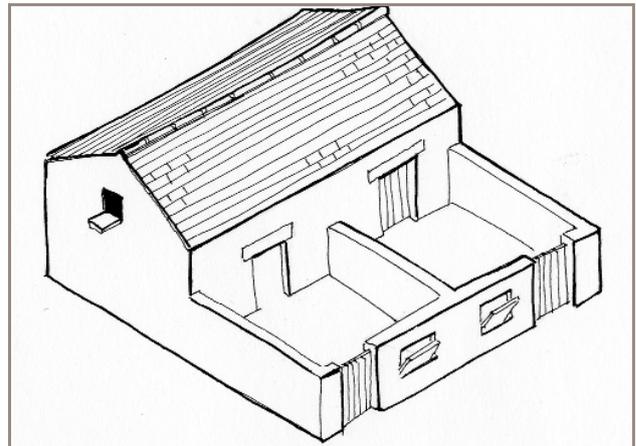
7.6 Pigsties with hen house over

7.4 Smaller outbuildings may include a granary over a cart shed (7.5), a stable, a shelter shed, or a pig-sty with a hen house above (7.6). The stable will generally be near the house, have a larger door than the cowhouse, and have a window adjacent to the door (7.7). The best groups in Horton are at Newhouse and Boot Hall. Both have composite barns and a full range of small to medium ancillary buildings. Horton Hall's curtilage buildings are atypical, reflecting its status as a gentry house.

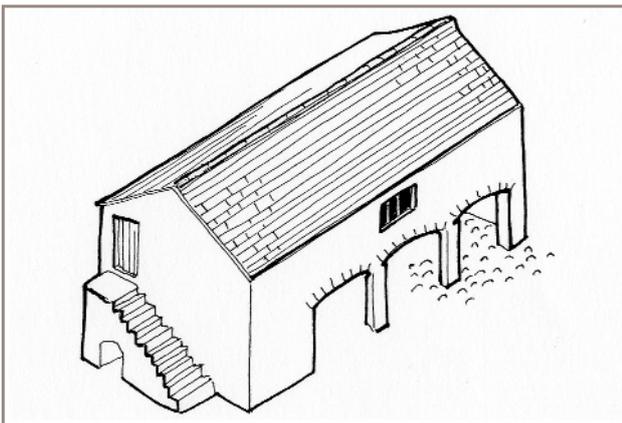
7.5 A shelter shed with granary over

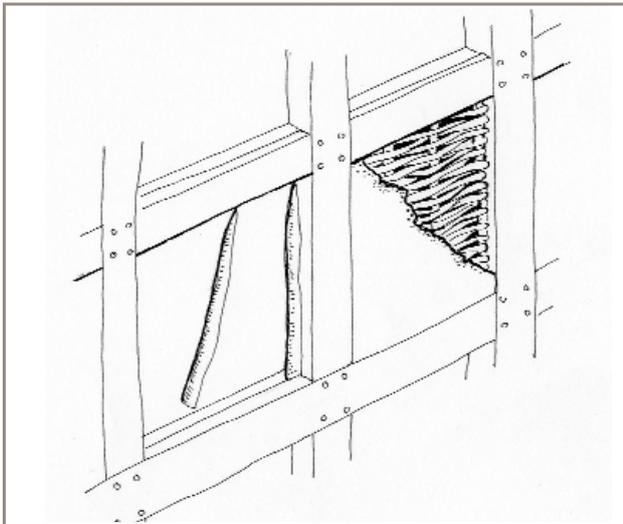
7.8 Square framing with wattle and daub

- 7.5 Oak, was the main building material in the Middle Ages, except for high status buildings. Where good building stone was absent timber remained in use until the 17th century.
- 7.6 Walling consisted of either square framed panels with wattle and daub, or close-studding with split laths and daub. Interior walling was still built in this way well into the 18th century (7.8) and is a feature of the earlier houses in Horton.

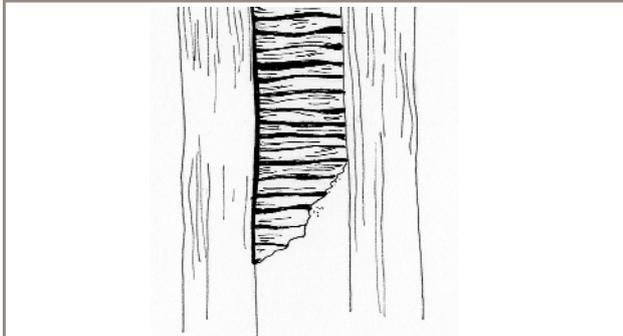
7.8 Close studding with split laths and plaster

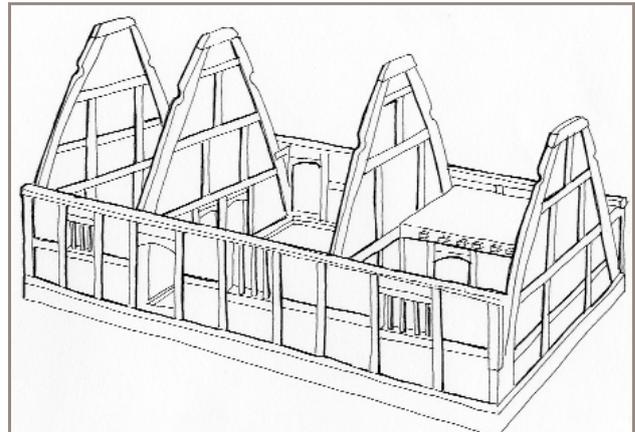
7.9 Cruck construction

7.7 Small buildings might be cruck framed with little or no headroom in the upper storey (7.9). Cruck frames survive in the rear of the former Crown Inn, and at Newhouse indicating a 16th century origin.

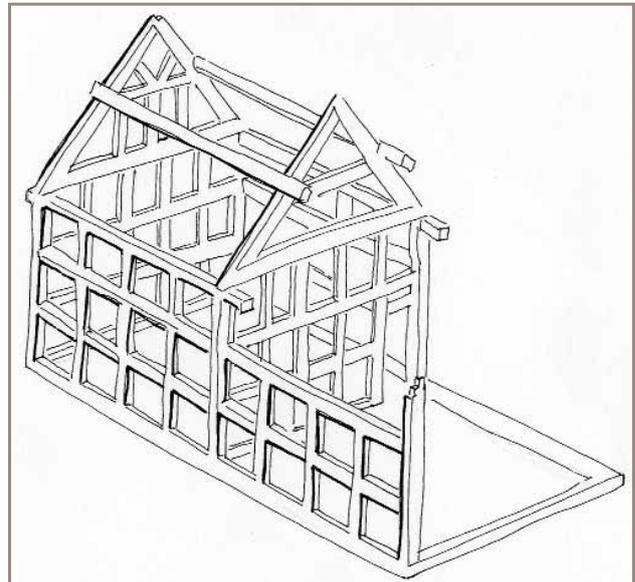
7.10 Box-framing

7.8 Larger houses were box-framed and had greater headroom (7.10). There are none in Horton Conservation Area, reflecting the durable quality of the local building stone.

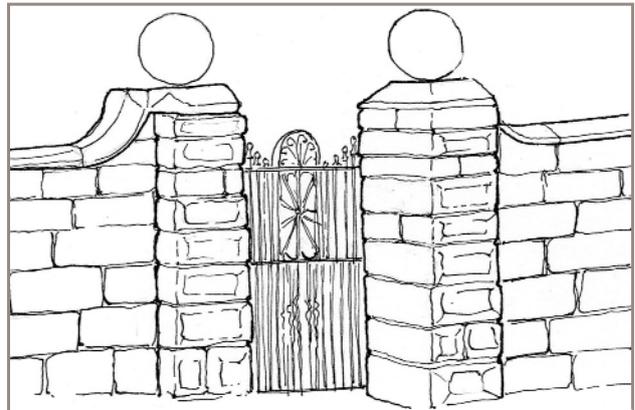
7.11 High status walling and gateposts

- 7.13 The status of a house and its owner were mirrored in the garden walls. Mortared walling with well-tooled capping stones and decorative gateposts were provided for gentry houses (7.11), and dry stone walls with simple capping stones for farmhouses and cottages (7.12). These contrasts are an essential part of the character of Horton, reflecting the high status of Horton Hall and the lesser status of other buildings.

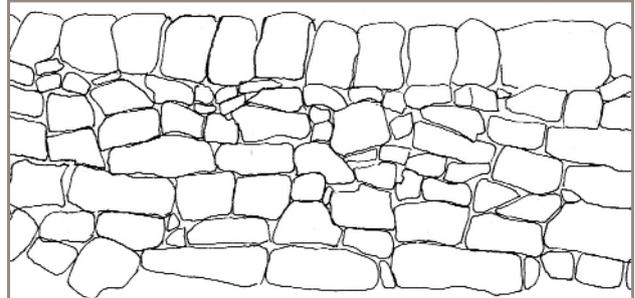
7.12 Drystone walling with the traditional half-round of coping stones

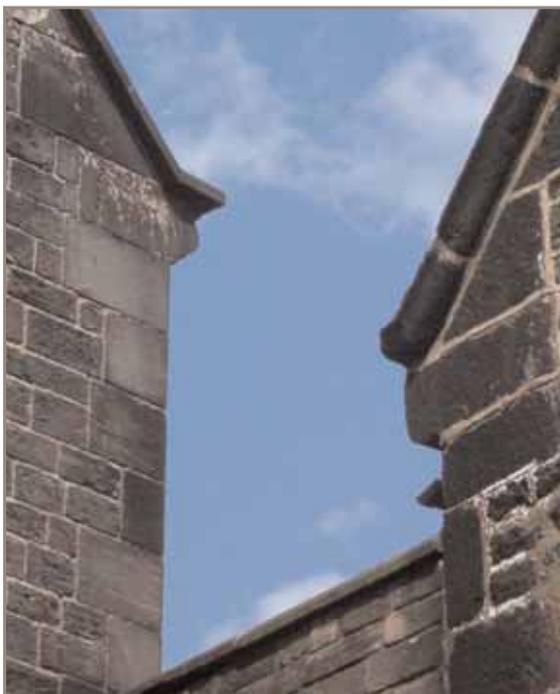
7.13 Coping stones and kneelers

- 7.18 Coping stones were either hog-backed (17th century) or flat (18th and 19th centuries), the latter shaped to throw water onto the roof and towards the guttering system. Hog-backed coping supported by distinctive 17th century style kneelers (7.13) gave way to plainer examples in the 18th century. If a roof was extended the copings would be moved and replaced on the new gable. Horton Hall has fine quality 17th century copings, and they survive on both house and barns at Boot Hall. Flat copings are visible on a number of the 18th and 19th century buildings in Horton.

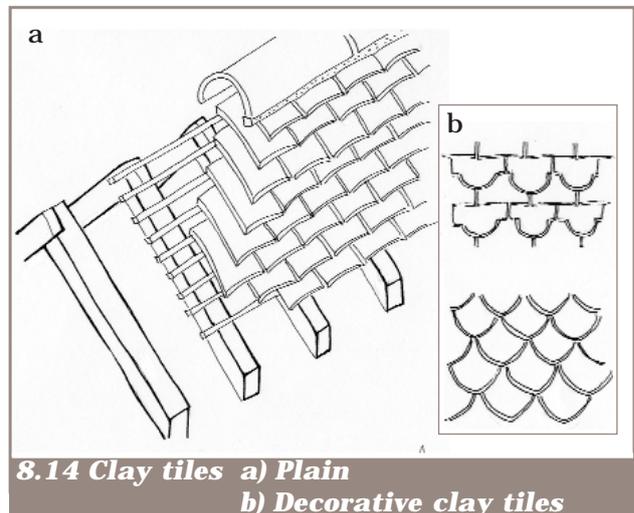
8.14 Clay tiles a) Plain b) Decorative clay tiles

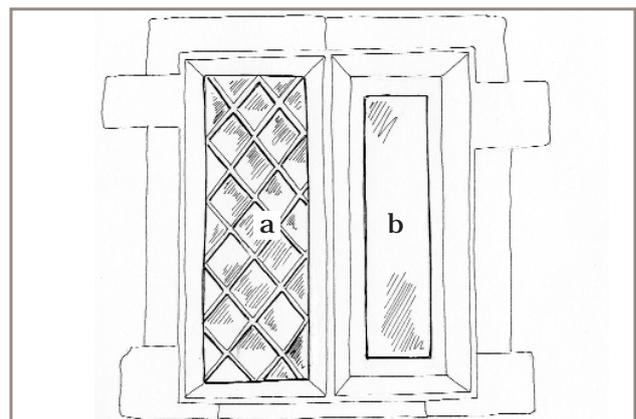
7.15 Mullioned windows: traditional and non-traditional methods of glazing
a) leading with diamond panes
b) wooden frame with single pane

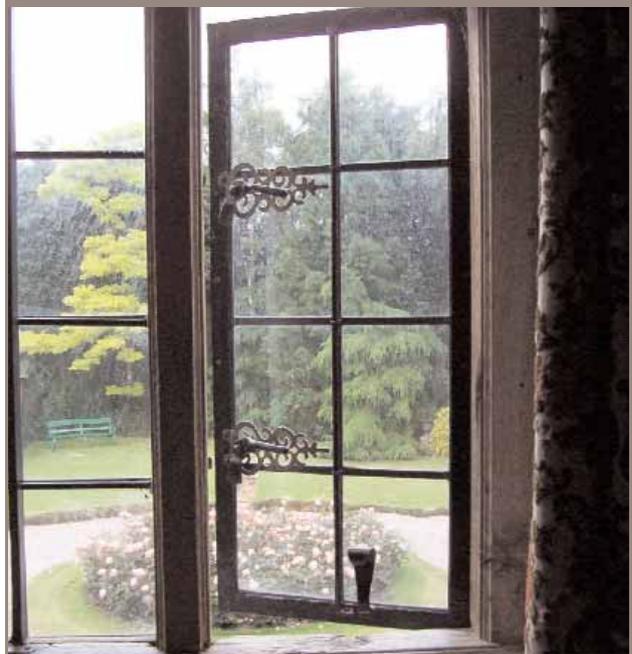
7.17 Casement windows

a) 18th century metal casement

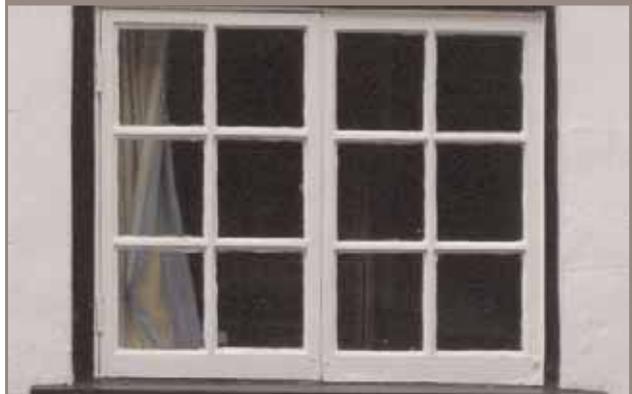
b) 19th century wooden casement

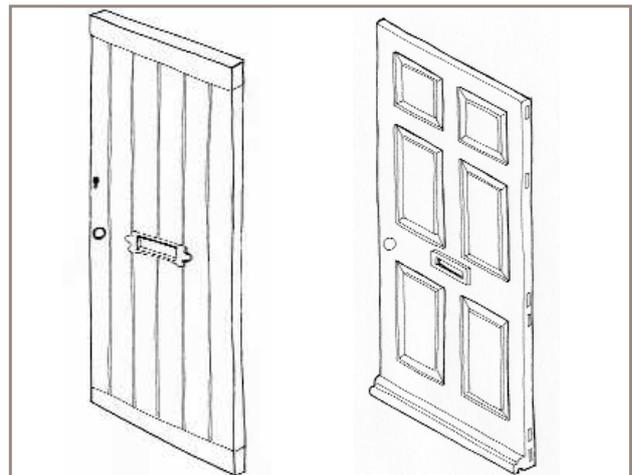
7.19 Doors

- 7.41 The simpler buildings in both town and country generally had vertically boarded doors, as did farm buildings (5.6). The latter might include stable doors with an upper section could be fixed open while the lower section remained closed. Good examples of both doors and shutters to pitching holes survive among the farm buildings at both Newhouse (5.8) and Boot Hall (5.9). Panelled exterior doors are common as exterior doors for higher status houses, and are often used for the front door of a farmhouse in contrast to plank doors at the rear (7.19).

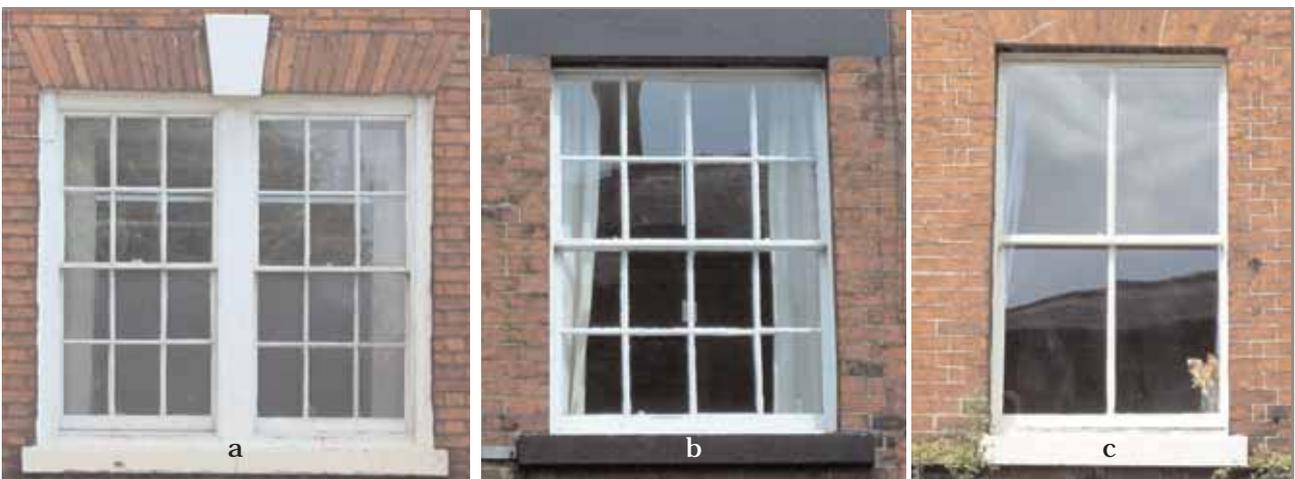
7.18 Vertical sliding sashes

a) 18th century, exposed sash boxes, 6 over 6 panes
